# *PHASE I ENVIRONMENTAL SITE ASSESSMENT*

**IRS Federal Building  
106 South 15th Street  
Omaha, Nebraska 68102  
Building No.: NE0032ZZ**

**Prepared for:**  
General Services Administration  
Attn: Mr. Kevin Santee  
1500 East Bannister Road  
Kansas City, MO 64131  
March 30, 2001  
**MES Project No. MES-01-2001-0003**

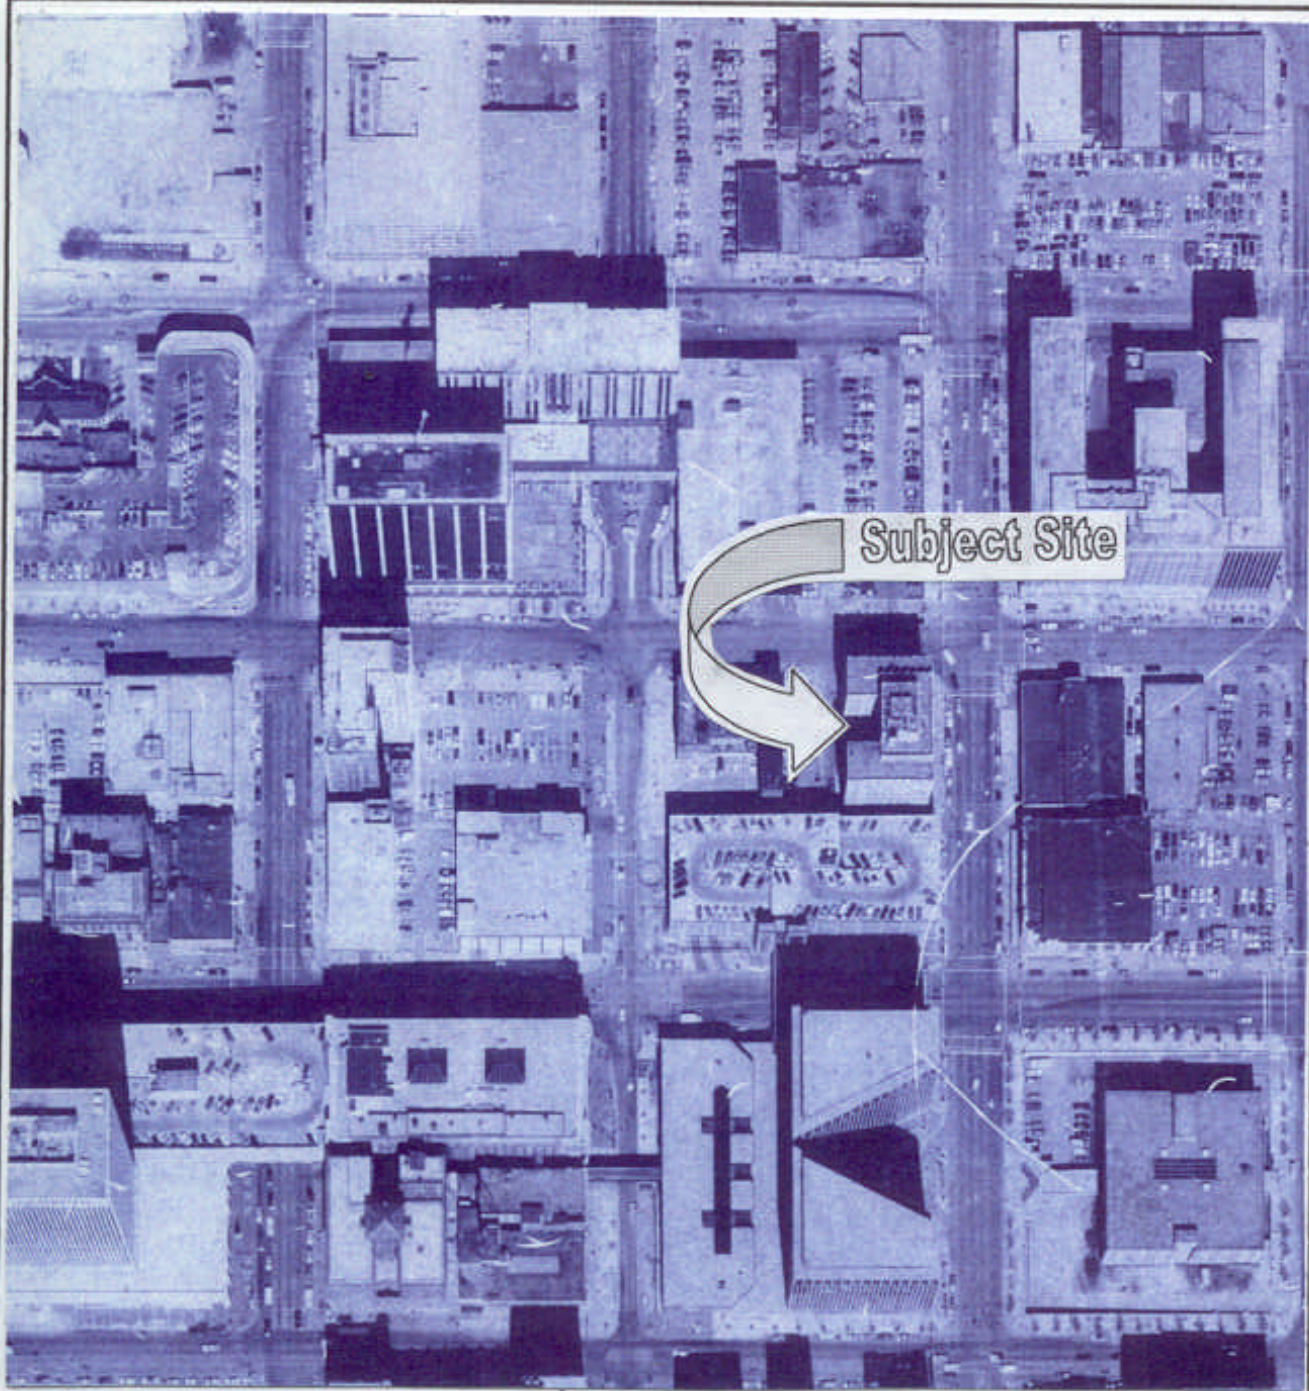
Figure No.:04

1985	<p>The aerial photograph shows the Site with the structure, which is currently located on the corner of 15<sup>th</sup> and Dodge Streets. The area is in a Central Business District. Adjacent businesses include parking (north), office space (northeast), a hotel (northwest), and a multi-level parking structure (south).</p> <p>No evidence of recognized environmental conditions are evident.</p> <p>A copy of this aerial is included in the Appendix as <a href="#">Figure No.: 04</a>. The original aerial can be found at the City of Omaha Planning Department.</p>
1998	<p>The aerial photograph shows the Site with the structure, which is currently located on the corner of 15<sup>th</sup> and Dodge Streets. The area is in a Central Business District. Adjacent businesses include parking (north), office space (northeast), a hotel (northwest), street level parking (southeast) and a multi-level parking structure (south).</p> <p>No evidence of recognized environmental conditions are evident.</p> <p>A copy of this aerial is included in the Appendix as <a href="#">Figure No.: 03</a>. The original aerial can be found at the City of Omaha Planning Department.</p>

Source: City of Omaha Planning Department  
Omaha, Nebr. - May 1985.

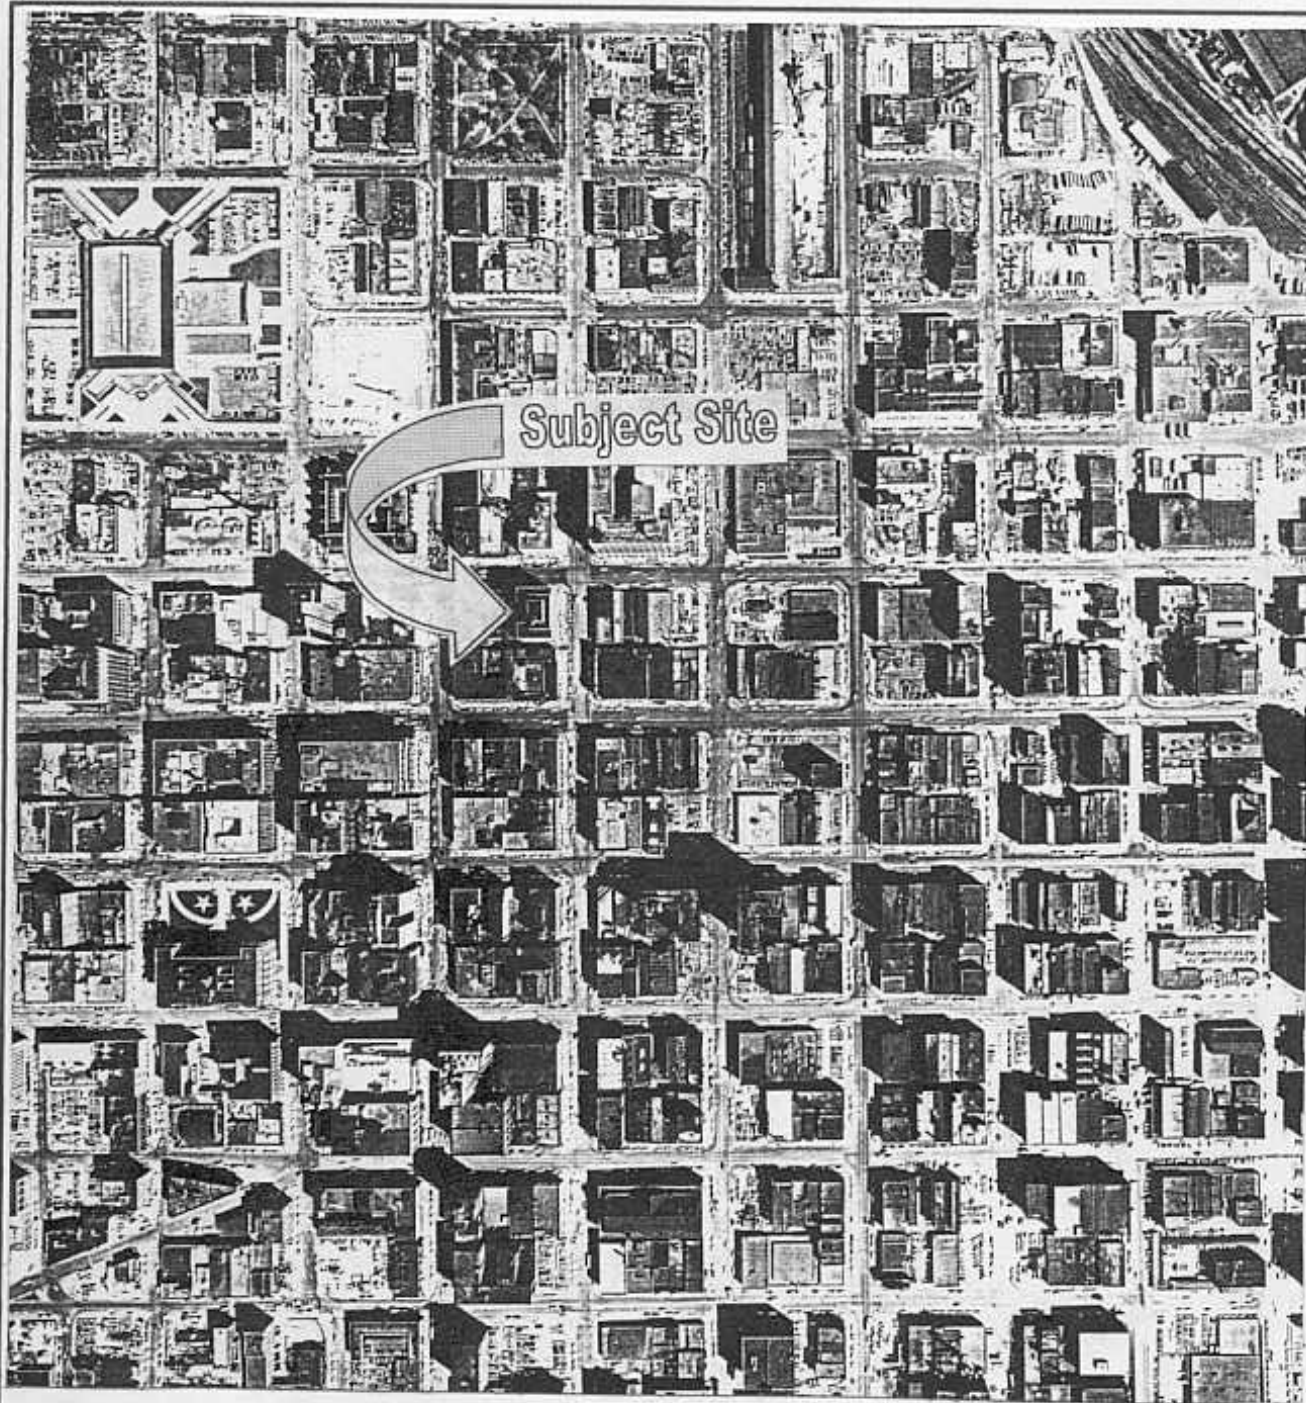
Figure No.: 06

Date of Aerial	Comments
1958	<p>The aerial photograph shows the Site with the structure, which is currently located on the corner of 15<sup>th</sup> and Dodge Streets. The area is in a Central Business District. Office buildings and parking lots are seen.</p> <p>No evidence of recognized environmental conditions are evident. The detail in this map is difficult to interpret due to the map's original condition.</p> <p>A copy of this aerial is included in the Appendix as <a href="#">Figure No.: 06</a>. The original aerial can be found at the City of Omaha Planning Department.</p>
1976	<p>The aerial photograph shows the Site with the structure, which is currently located on the corner of 15<sup>th</sup> and Dodge Streets. The area is in a Central Business District. Office buildings and parking lots are seen. Adjacent businesses include parking (north), office space (northeast) and a hotel (northwest).</p> <p>No evidence of recognized environmental conditions are evident.</p> <p>A copy of this aerial is included in the Appendix as <a href="#">Figure No.: 05</a>. The original aerial can be found at the City of Omaha Planning Department.</p>

Source: City of Omaha Planning Department  
Omaha, Nebr. - 1958.

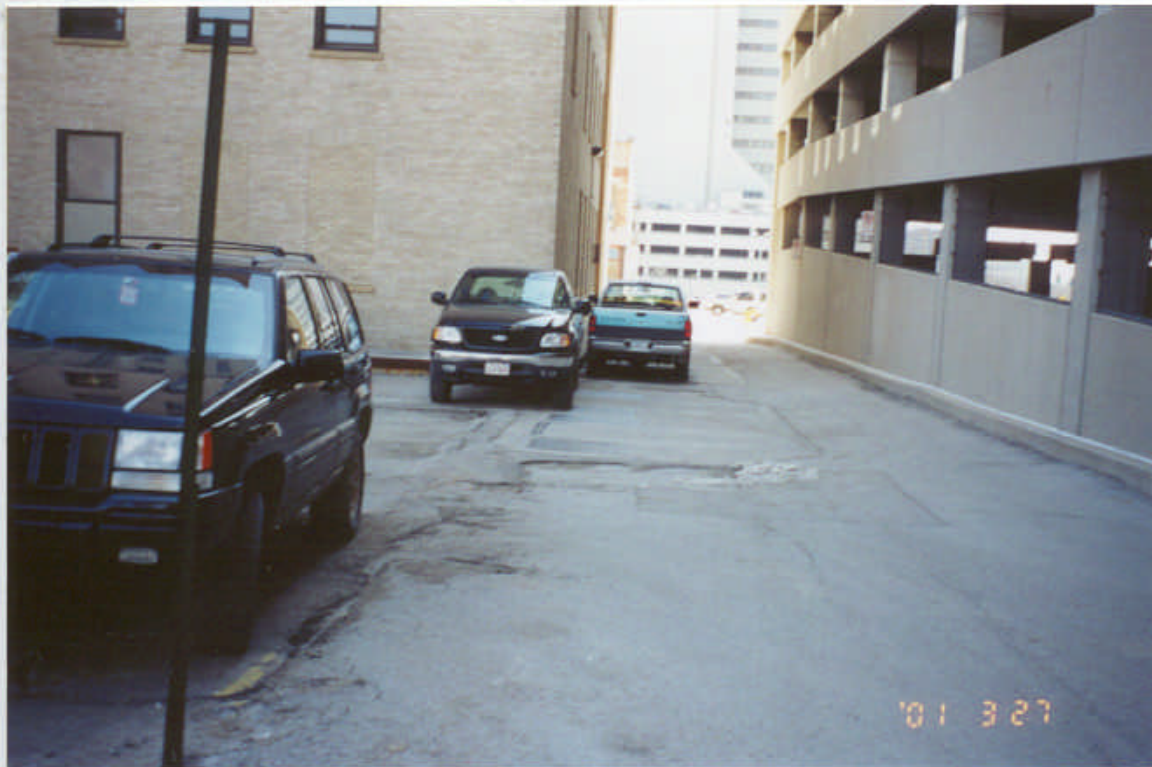
3

View is toward the east showing the Site on the left and the alleyway, which is immediately south of the Site.

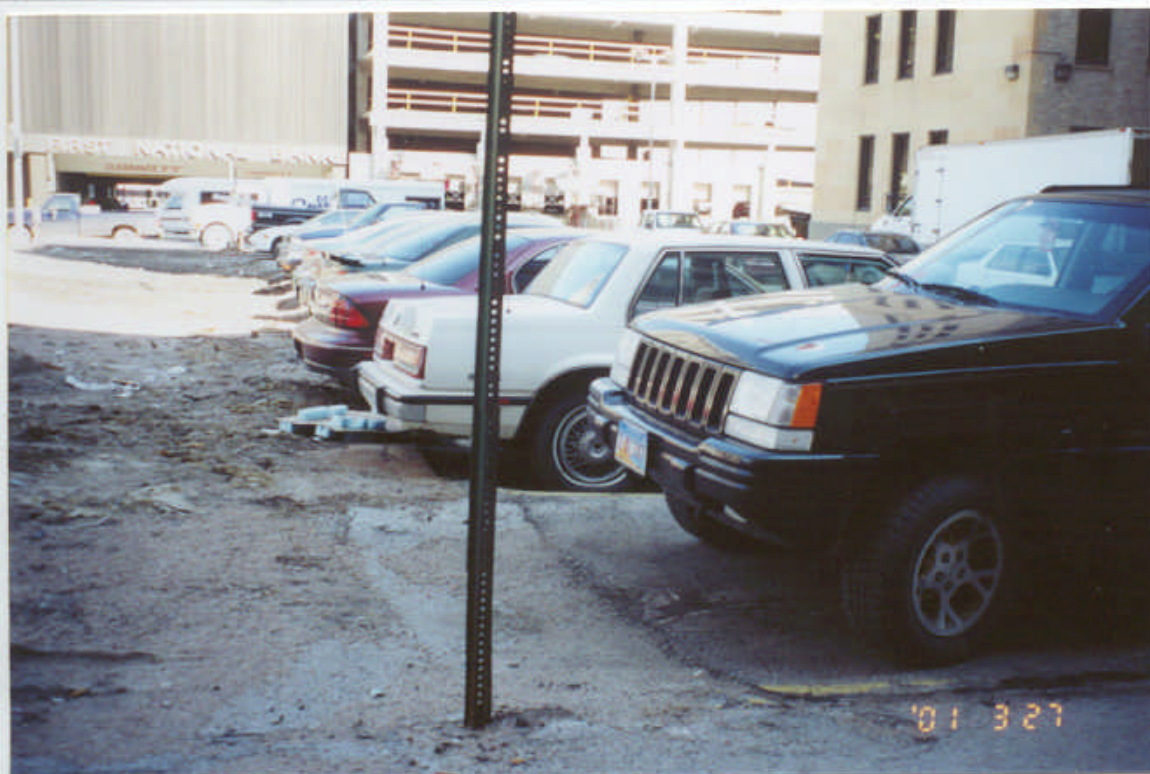
4

View is north and shows the westerly property line at the Site.

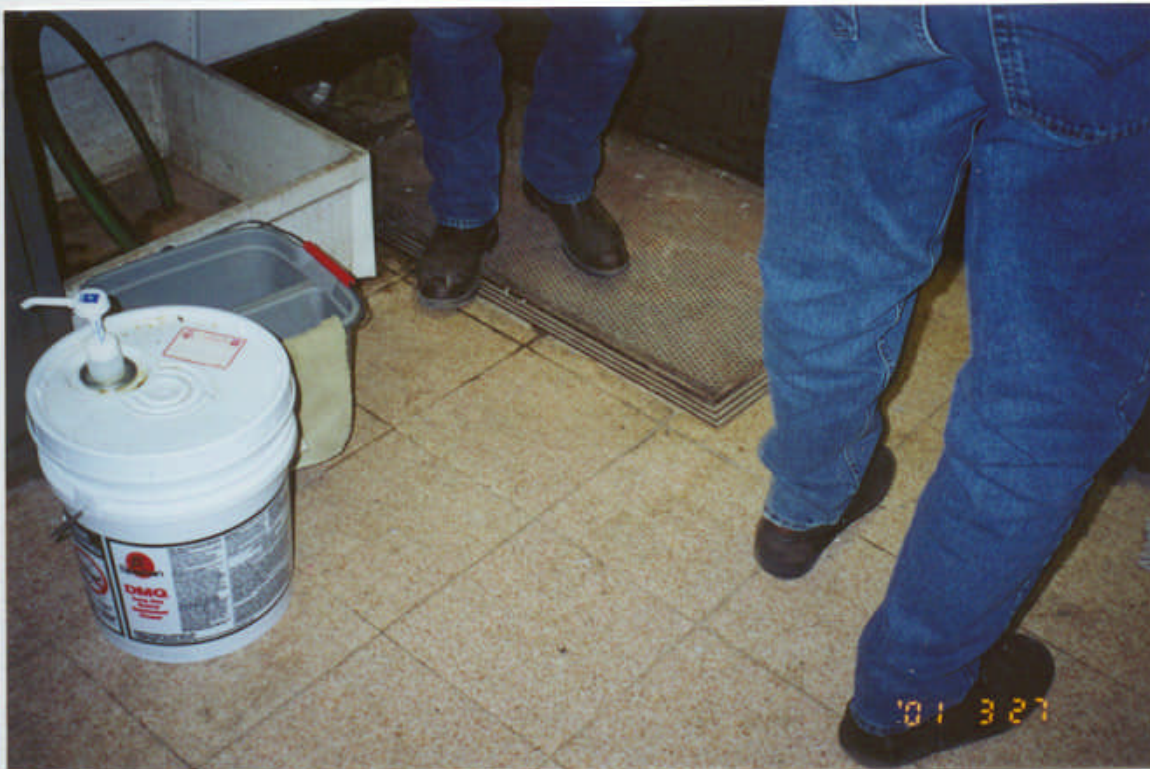
5

View shows a steel trap door in the basement, which is the entrance to the crawl space under the building on the Site.

The exterior parking, located on the west side of the structure at the Site, is improved with asphalt for Federal employee use. Reference [Photograph Numbers 3 and 4](#) in the Appendix. Transformers for the building are reportedly mounted in underground vaults in the City alleyway, immediately south of the Site. Reference [Photograph Number 3](#) in the Appendix. A loading/unloading dock is located on the west side of the structure. Reference [Photograph Number 8](#) in the Appendix. The interior of the building, on the Site, is in good condition. In the basement, a crawl space exists reportedly giving access to areas dating prior to the 1930s. Reference [Photograph Number 5](#) in the Appendix. The photograph shows a steel trap door mounted in the floor. There is no ladder way to gain access to the soil floor beneath the trap door. Additionally, the area below the trap door is a confined space and observations, for this report, could only be made above the floor surface. The crawl space is reportedly a narrow tunnel used for utilities, which traverses the bottom of the structure from the south side to the north side of the basement. Observations were previously made in the early 1990s when personnel accessed the tunnel, approximately half of the distance through the crawl space. No further information was available on other aspects of this issue.

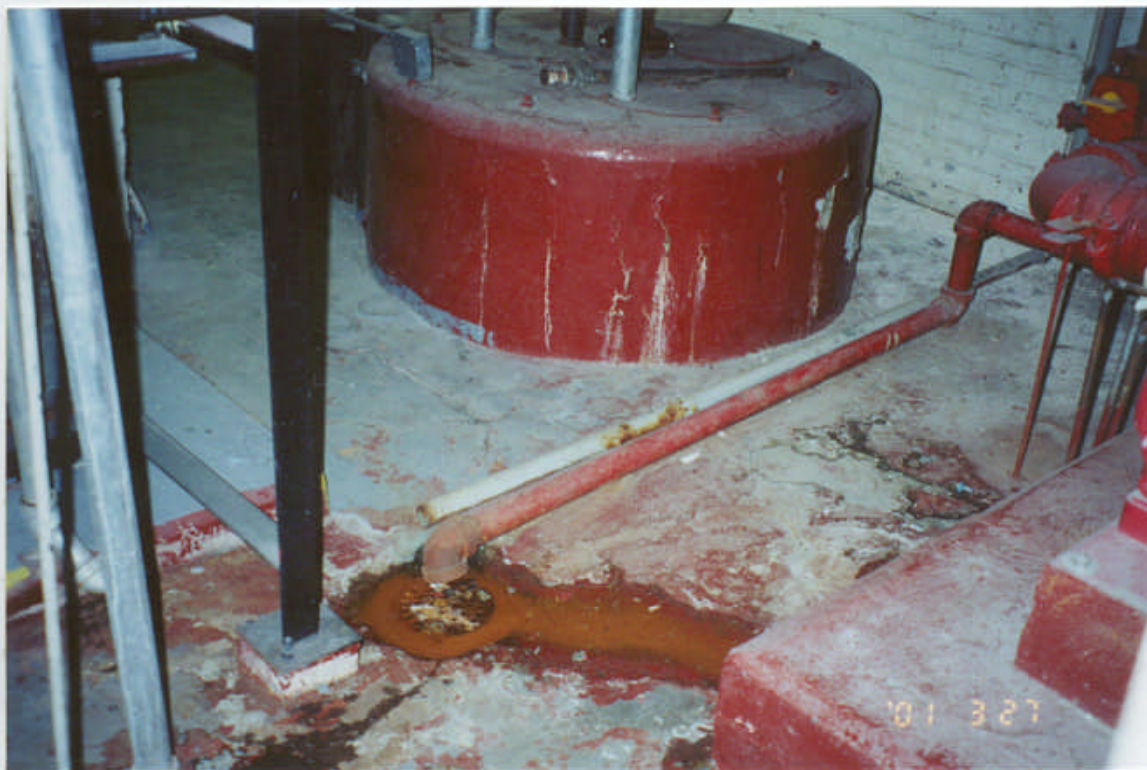
6

Floor drains are located in the basement's Boiler Room and route water to a sump. Reference [Photograph Number 06](#) in the Appendix. The sump also is used to capture discharge water from the fire protection lines when they are tested. The collection of the drainage is manually pumped up to the City sewers following observations of the sump contents. Located in the basement, near the Boiler Room were small amounts of hazardous materials including mineral spirits, oils, paints and cleaners. The mineral spirits are used to clean paintbrushes and the waste material is captured and disposed by the General Services Administration. All hazardous materials are captured and properly disposed of. A hydraulic operated elevator was observed. Reference [Photograph Number 7](#) in the Appendix. Hydraulic oil was stored in a tank and piping observed under the elevator shaft. There were no floor drains in the vicinity of this hydraulic system.

View shows a floor drain and the sump in the Boiler Room located in the basement of the structure on the Site.

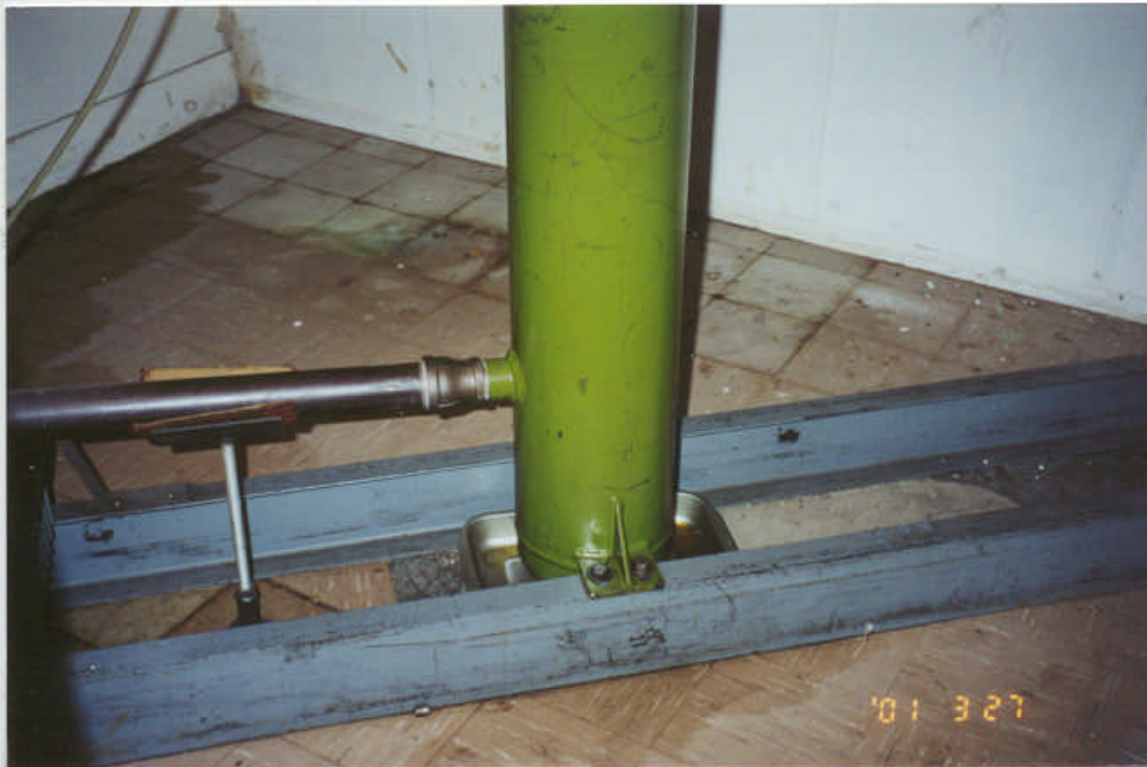
7

View shows the hydraulic components of an elevator in the basement of the building on the Site.

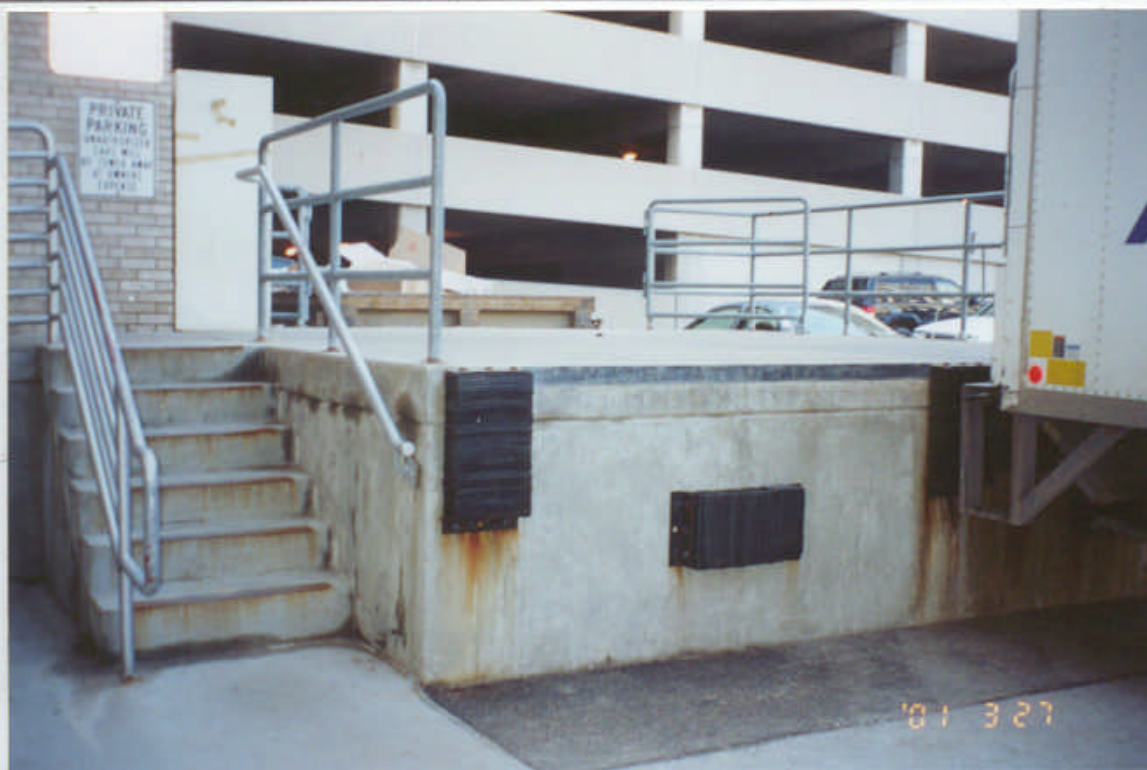
8

View is southwest and shows the loading/unloading dock located on the West Side of the structure on the Site.

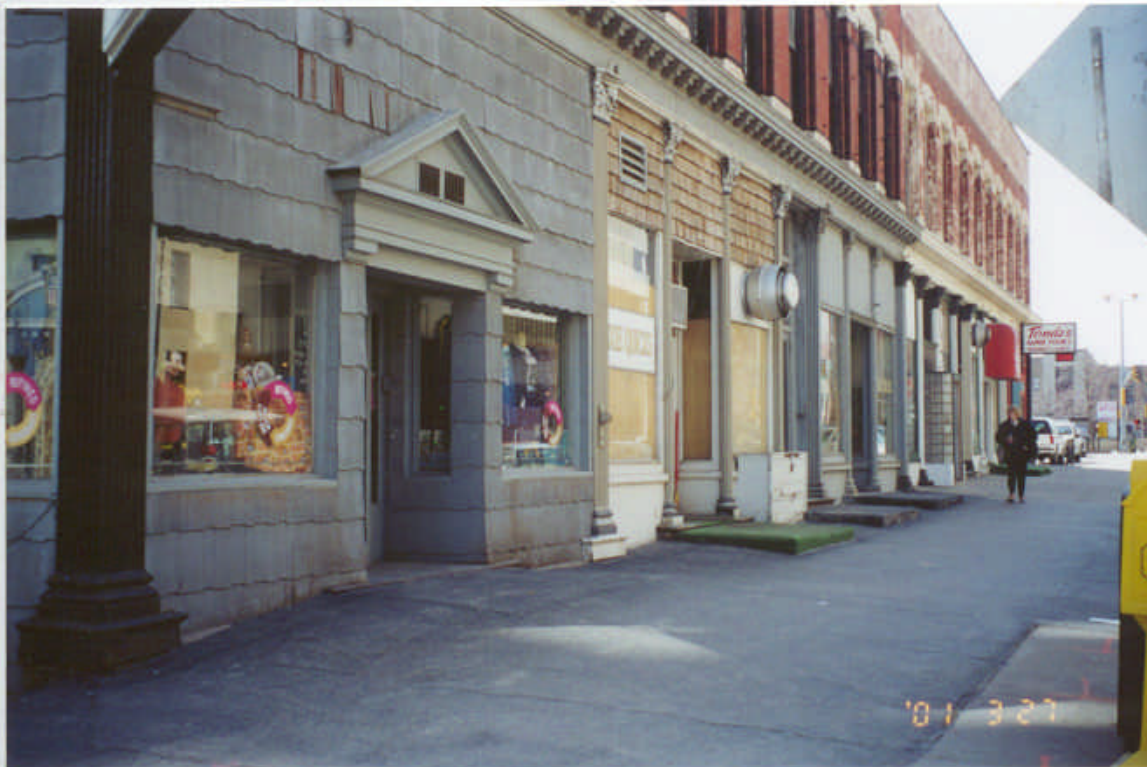
13

The recognized environmental conditions pertaining to the Site associated with the City Directory includes the dry cleaning operations (located immediately adjacent to the Site, east of 15<sup>th</sup> Street), a printer (located immediately adjacent to the Site, east of 15<sup>th</sup> Street), and the operations conducted at the Site by the military branches of the government.

View is southeast and shows the adjacent structure east of the Site where a dry cleaning operation previously existed.

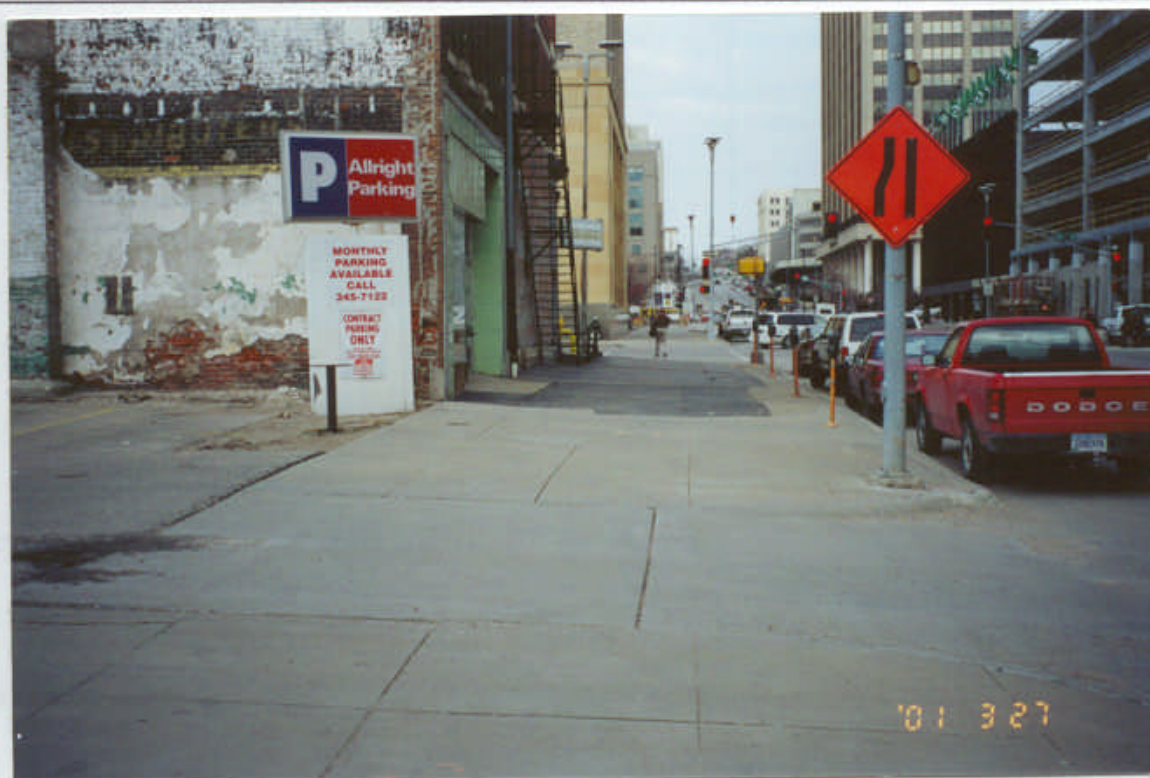
14

East	A parking lot exists. A gas station was previously noted at this location in the Sanborn Maps. No evidence of the station was observed.	<a href="#">Photograph Number 14</a>
South	A multi-storied automobile parking structure.	<a href="#">Photograph Number 11</a>
West	Automobile parking.	<a href="#">Photograph Number 2</a>

View is west and shows the approximate location where a gasoline station existed. The Site is seen in the background.
